Minnesota Wetland Health Evaluation Program 2011

Hennepin County
Environmental Services

Hennepin County Wetlands Monitored in 2011

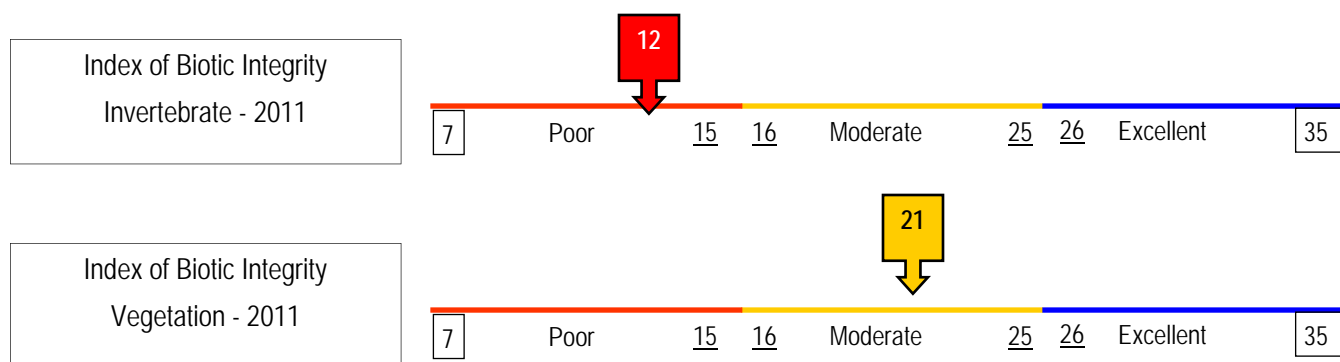
This wetland was added in 2011 after high water kept the Bloomington team from monitoring the reference wetland of Nine Mile Creek. Timberglade Pond is bordered by 102nd Street to the north, Wildwood Rd. to the east and Timberglade Road to the south. Mature woods surround this pond with homes along the west and east shore. Development appears imminent along the south shore as well. This site is across 102nd St. from Hyland Greens Golf Course.

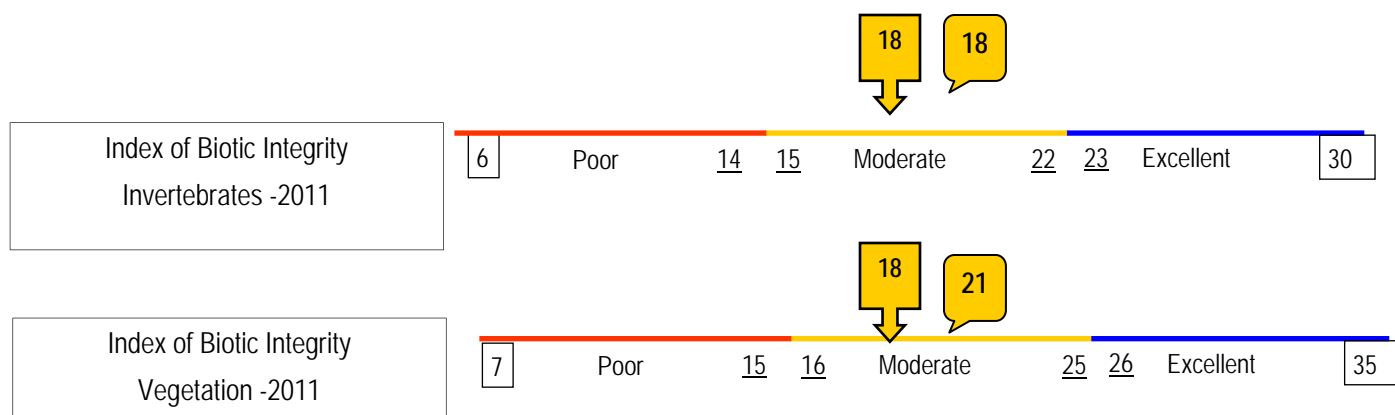
Brooklyn Center Site: BC-1 Palmer Lake

This small wetland is part of the Palmer Lake complex and lies fully surrounded by vegetation on the southwest corner of the lake. Just south of the wetland is a park-and-ride lot off of County Road 130 (or 69th Avenue). There is a public landing adjacent to this wetland and a trodden path for access.

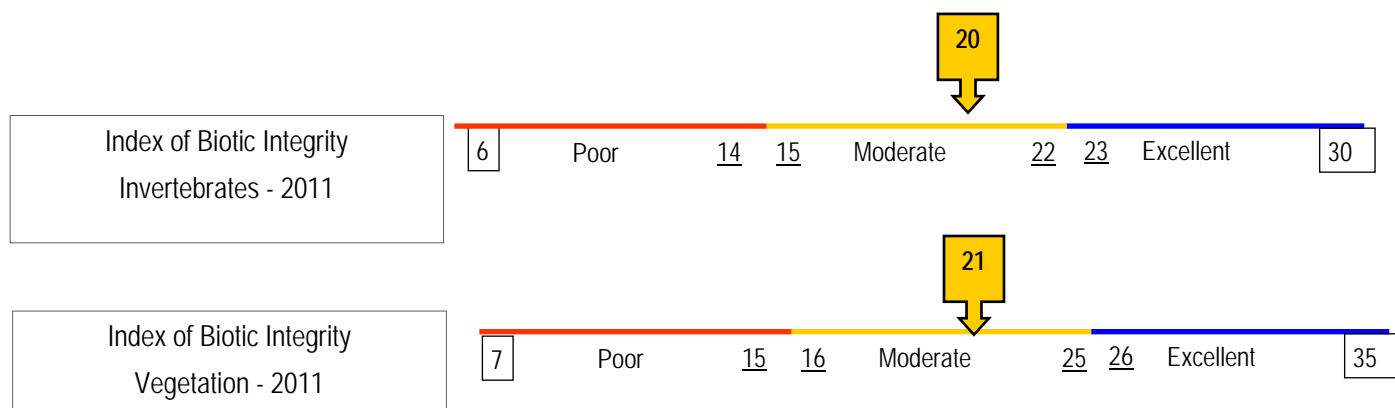
Brooklyn Park Site: BP-1 Environmental Preserve

This site is located across the street from the Coon Rapids Dam on Russell Avenue. It lies within the Brooklyn Park Environmental Area and is surrounded by a mixture of tall grasses, shrubs and large trees. There is high foot and bicycle traffic along this wetland. There is a long gentle slope into the water from the upland area. The bottom is moderately mucky with some solid areas. There is an outlet at the northern edge of the site and an inlet at the southern end. The water level fluctuates significantly.

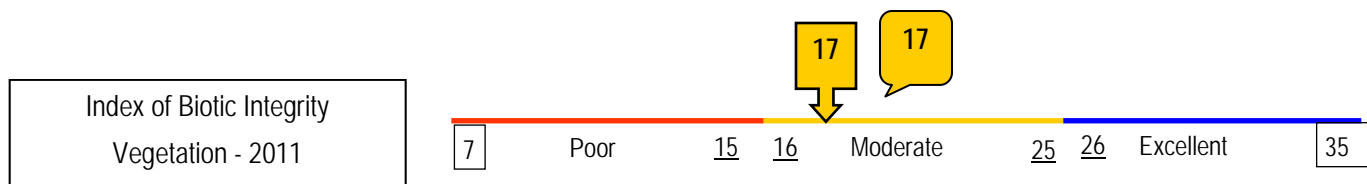
Corcoran
Site: CO-1
Corcoran City Hall

Site CO-1 is located within Corcoran adjacent to the City Hall. The wetland is on the corner of County Highway 116 and Schutte Place. The surrounding land use includes farming, residential homes, and two small tree groves. Grass is mown up to the wetland edge on the side of City Hall and along the highway.

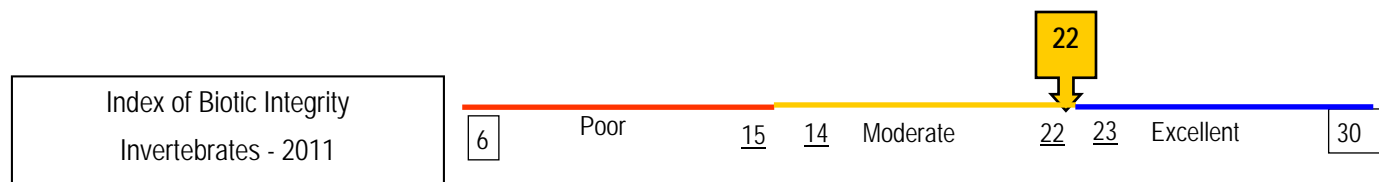
Eden Prairie
Site: EP-21
Round Lake Park East

The wetland is located just west of Eden Prairie Road with the southern boundary marked by Luther Road. This is a small wetland that has a relatively newly restored buffer. Along the southern edge is a block of homes and a ball field is nestled along the western edge.

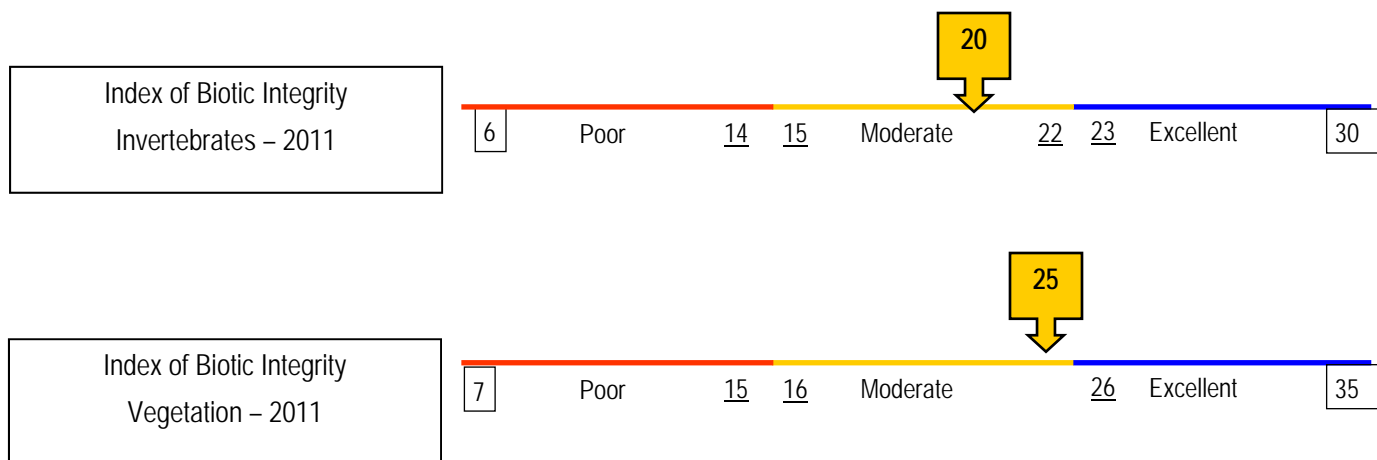
Eden Prairie Site: EP-22 Technology Drive

This site abuts Technology Drive and is the smallest wetland in the complex. The southeastern boundary is all cattail. There is a large building just to the west. Between EP-22 and the next closest wetland, the area appears to have been restored. The team noted an interesting blue tint to the water in both neighboring wetlands on their first trip to the site in June.

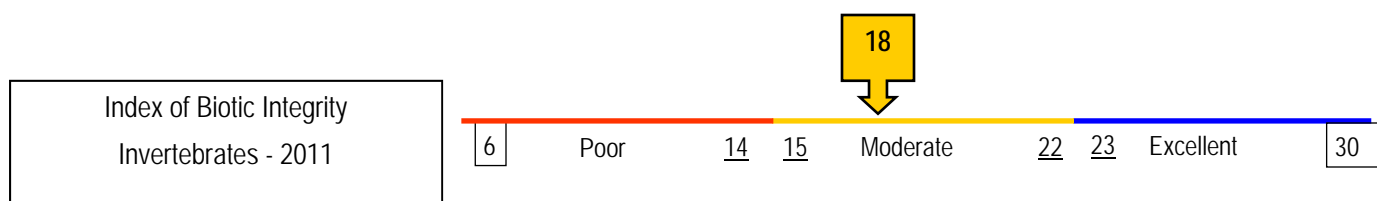
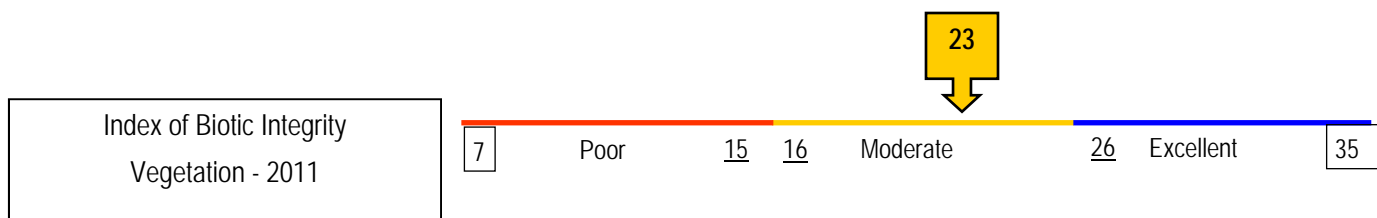
Eden Prairie
Site: EP-23
Braxton Lake Pond

This site is in the middle of a heavy residential area. The edge is completely surrounded by homes and the only access is through backyards. Cedar Ridge Elementary School is to the east.

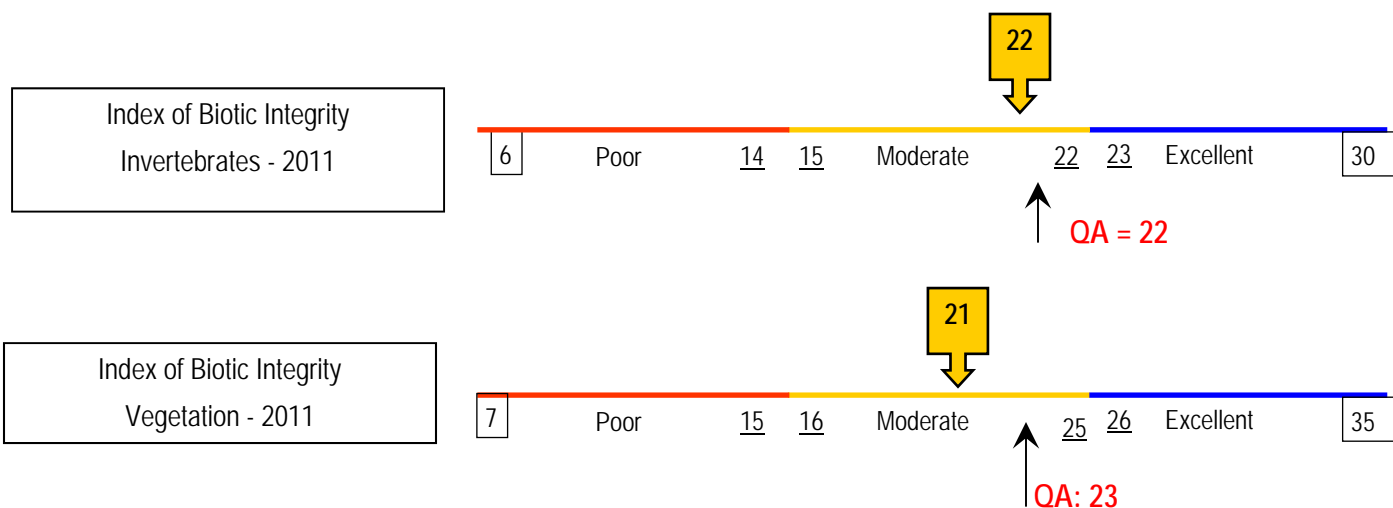
Site: MP-7

This site is located within public land in the Robert's Bird Sanctuary across the road from Lake Harriet. The ponds were created here by dredging around 1960 and were used by the DNR as a fishery from 1960 to the early 1970s. This area is mainly boggy soil surrounded by woods and semi-wooded park on three sides. The sampling site is separated from the street by a fence and a boulevard strip. his year.

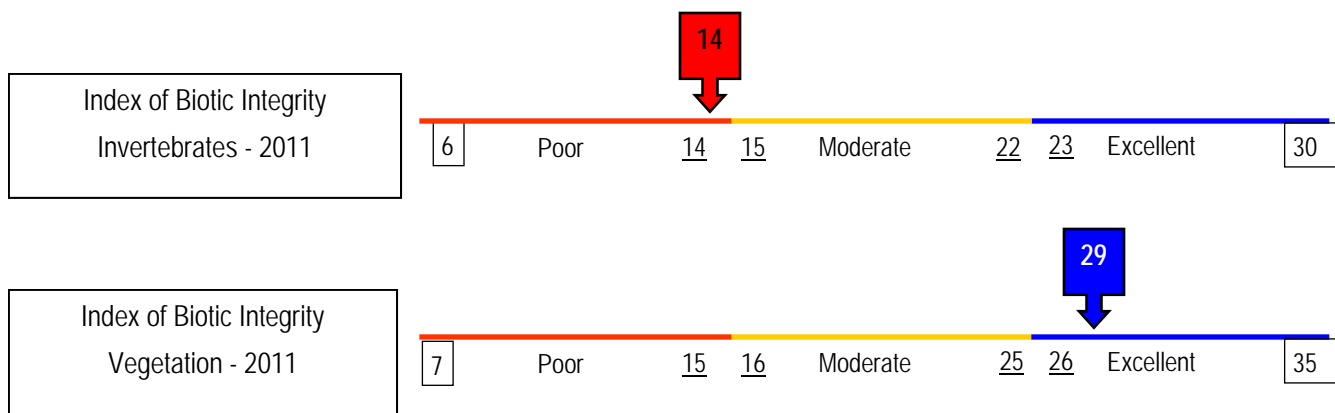
Site: MP-12

This monitoring site is in Webber Park nestled among tennis courts, a public swimming pool, Shingle Creek and two major roadways. The water level in this wetland is maintained by an augmentation well and is stocked every year by the Department of Natural Resources for the Fishing in Neighborhoods program. The infamous “Minneapolis Muckstars” report a huge abundance of predators such as amphibians, ducks, herons and egrets. The low score for inverts suggests a healthy feed ground. This wetland is stocked with fish as part of the DNR’s “Fishing in the Neighborhoods” program. The vegetation is intentionally diverse as the shoreline has undergone restoration efforts.

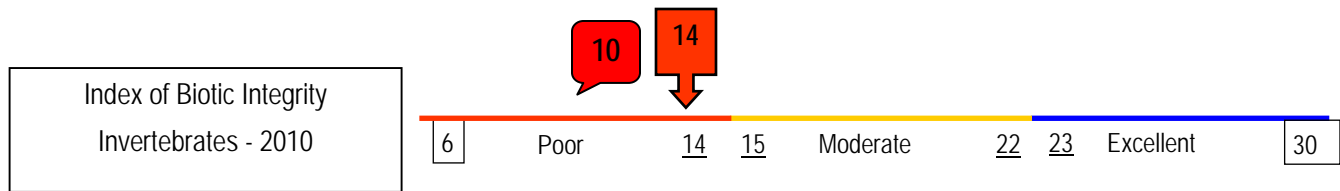
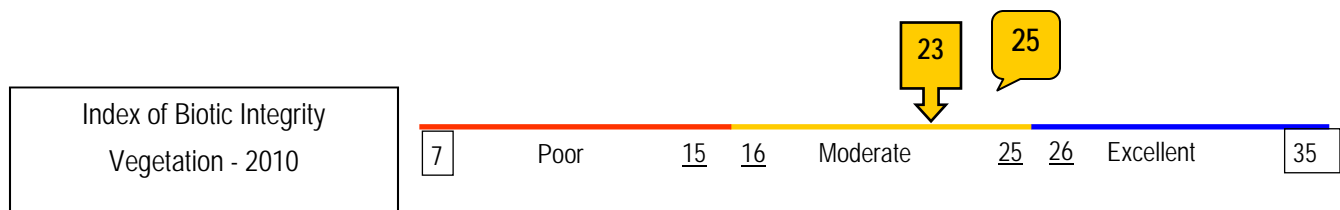
Site: MP-13

This wetland is a stormwater catchment basin that was “built” around the year 2000. The wetland is small and surrounded by trees and shrubs on one side and mown grass on the other. The team saw a small increase in invertebrate score, from “6” in 2009 with a slow increase of emergent vegetation. The higher vegetation score is indicative of the restoration efforts.

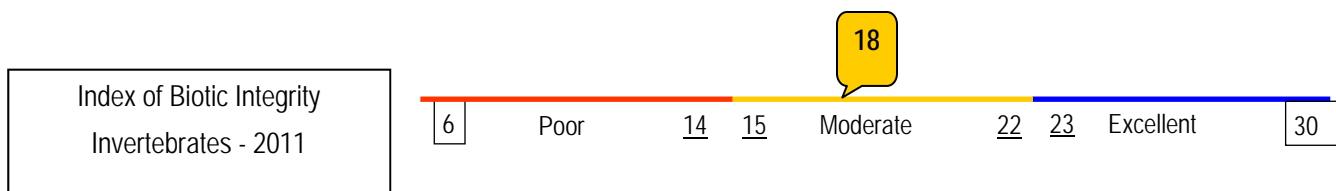
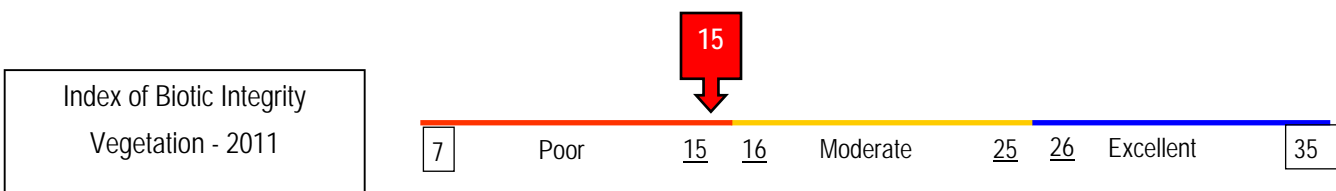
Charlotte Park

This wetland is situated between Birch Road and Norwood Drive in Minnetonka. On the south side of the wetland is a picnic area that is maintained by the City. The lawns surrounding the wetland are mown to the edge. There is a small area of open water but the entire wetland is abundant in leaf litter. This wetland serves primarily as a storm water runoff pond.

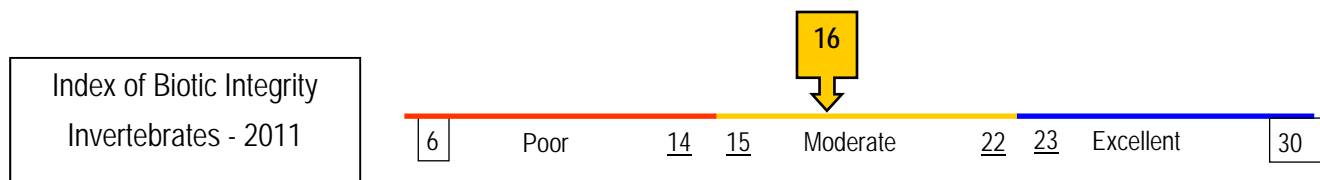
This wetland is located in a cul de sac on Nottingham Court road. This is a small shallow wetland surrounded by homes. The water level appeared low as the dock was dry and the shoreline indicated a history of higher water. There were signs of recreational activity on this wetland including a paddleboat as well as several wood duck homes situated along the wetland edge.
